Mapping Inundation extent for Puttalam District in North Western Province (Sri Lanka) using ALOS 2 PALSAR 2 Satellite Data (23 May 2018)

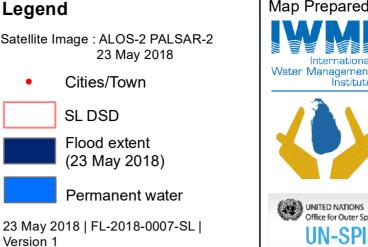
The satellite image from ALOS-2 PALSAR-2 taken on 23 May2018 showing considerable

inundation for Galle and reference to dark with deep water and dark grey color in the agriculture

The analysis excluded permanent water bodies including reservoir, tanks and ponds and this reflects only the inundation extent. Please note the surface water extent mapped has not yet been validated in the

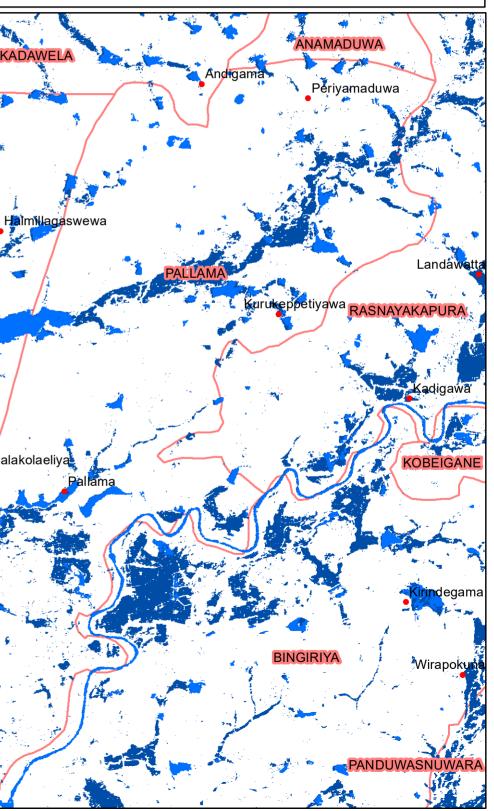
fields with water.
