Mapping Inundation extent for Colombo District in Western Province (Sri Lanka) using ALOS 2 PALSAR 2 Satellite Data (23 May 2018)

23 May 2018 | FL-2018-0005-SL | Version 1

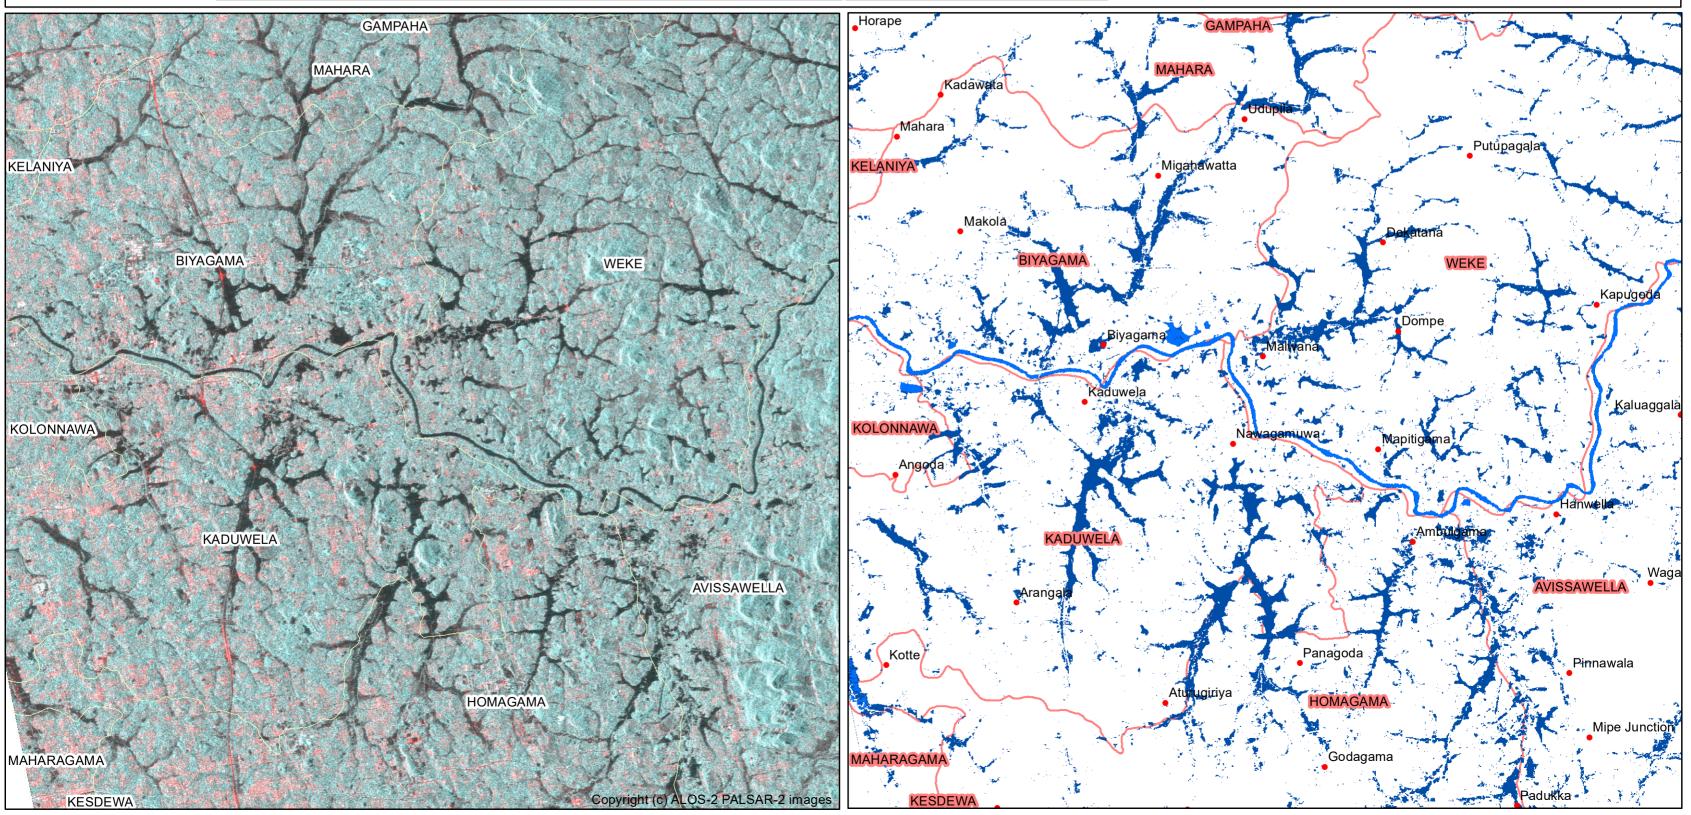
The initial satellite observations from ALOS-2 PALSAR-2 (23 May 2018) showed vast areas of standing flood waters along the North Western, Western and Southern Provinces. Initial estimates from satellite images indicate that Puttalam (96.1 sq.km), Kurunagala (198.6.sq.km), Gampaha (82.46 sq.km) Galle (25.5 sq.km, Kaluthara (22.1 sq.km), Rathnapura (10.4 km.sq), Colombo (4.2 sq.km). Most of the district flood is reducing but rivers are still under minor flood level.

The satellite image from ALOS-2 PALSAR-2 taken on 23 May2018 showing considerable inundation for Galle and reference to dark with deep water and dark grey color in the agriculture fields with water.

The analysis excluded permanent water bodies including reservoir, tanks and ponds and this reflects only the inundation extent. Please note the surface water extent mapped has not yet been validated in the
