# Mapping Inundation extent for Kalutara District in Western Province (Sri Lanka) using ALOS 2 PALSAR 2 Satellite Data (23 May 2018)

24 May 2018 | FL-2018-0002-SL |  
Version 1

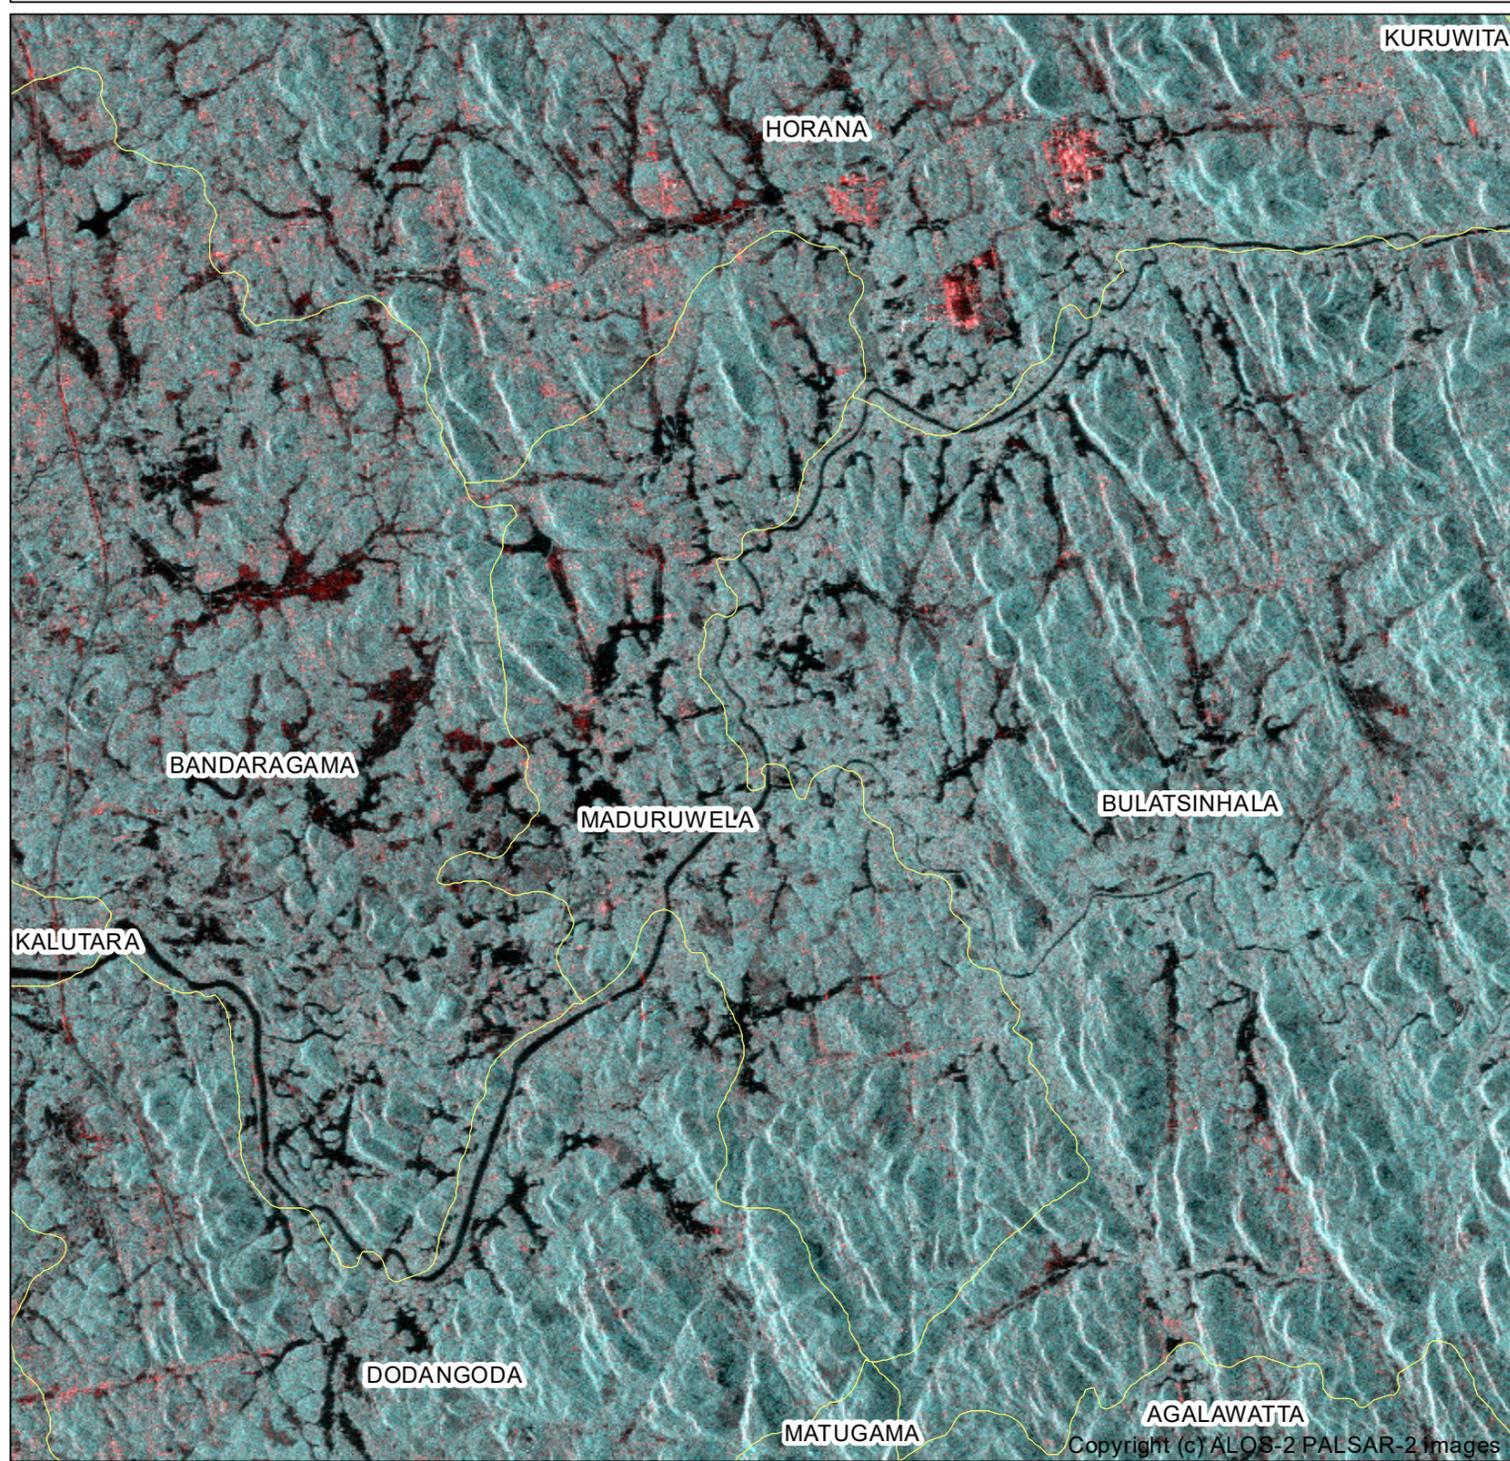
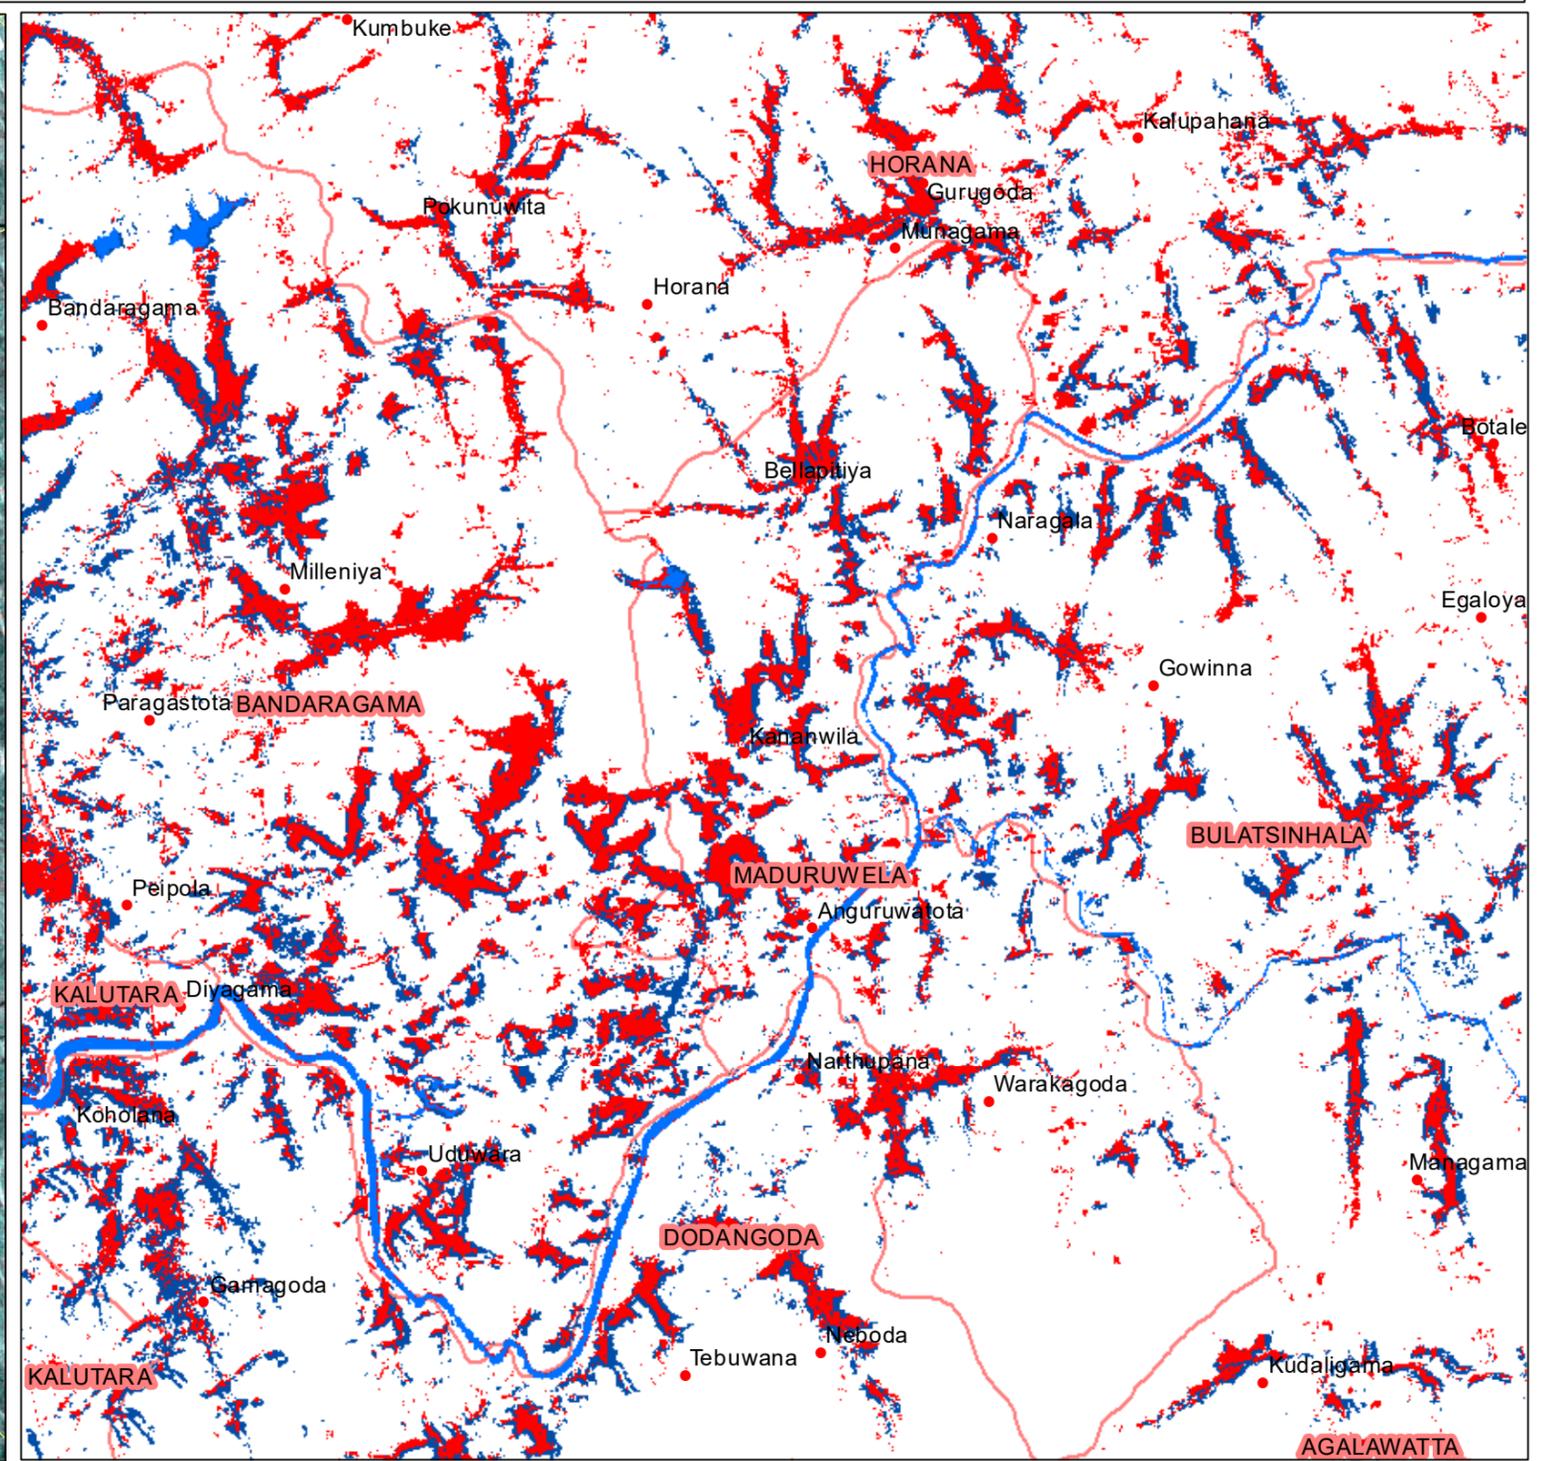
The initial satellite observations from ALOS-2 PALSAR-2 (23 May 2018) showed vast areas of standing flood waters along the North Western, Western and Southern Provinces. Initial estimates from satellite images indicate that Puttalam (96.1 sq.km), Kurunagala (198.6 sq.km), Gampaha (82.46 sq.km) Galle (25.5 sq.km), Kaluthara (22.1 sq.km), Rathnapura (10.4 km.sq), Colombo (4.2 sq.km). Most of the district flood is reducing but rivers are still under minor flood level.

The satellite image from ALOS-2 PALSAR-2 taken on 23 May 2018 showing considerable inundation for Galle and reference to dark with deep water and dark grey color in the agriculture fields with water.
